Performance of precast concrete structures in October 2011 Van earthquake, Turkey

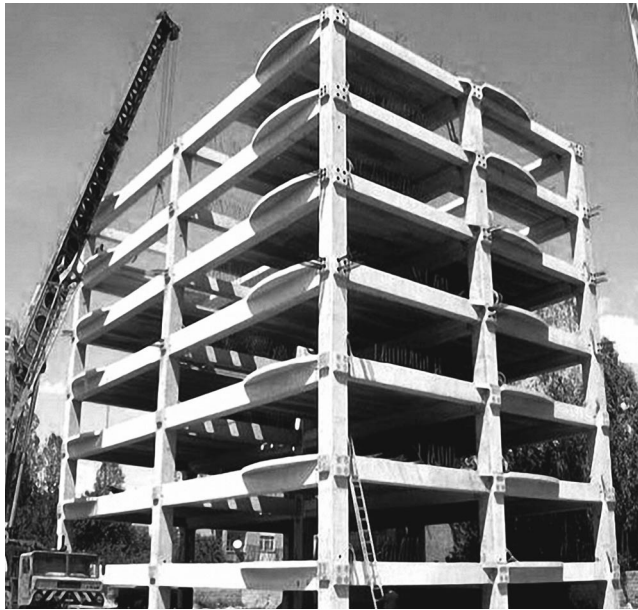
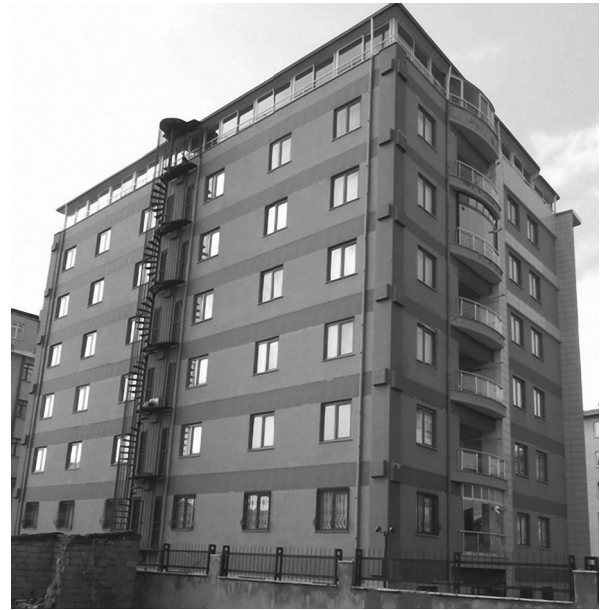
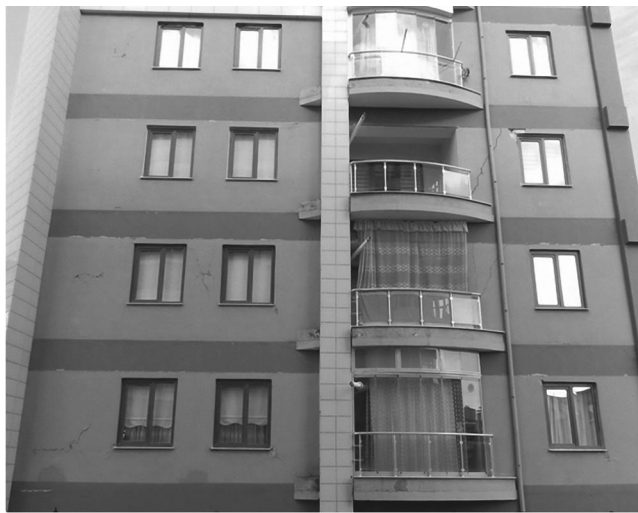
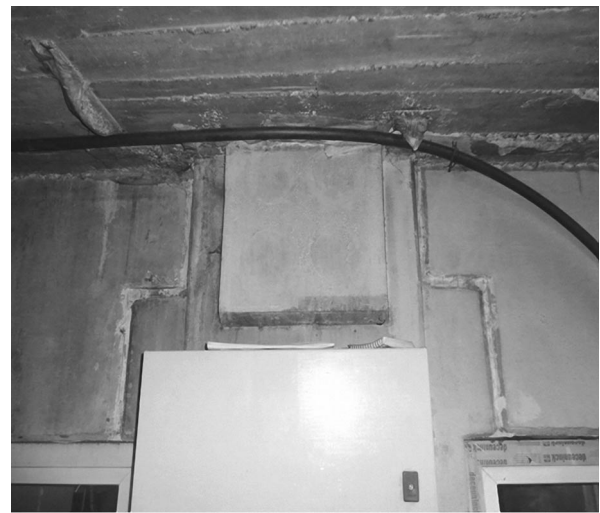
Figure 3. Multi-storey precast concrete building with post-tensioned connections

Post-earthquake damage investigation of that specific building revealed no structural damage of either the precast members or the post-tensioned connections (Figure 3(c)). The column-to-foundation connections were carefully investigated and no flexural or shear cracks were observed. No visible damage was detected on the structural frame components of the building after the Van earthquake of October 2011. On the other hand, 45° diagonal tension cracks were observed on the dry partition walls of the building (Figure 3(d)). This type of cosmetic damage reveals that there was incompatibility of deformation capacities between the non-structural walls and the frame. The frame remained relatively elastic, whereas the walls exceeded their failure displacement limit. The performance level of the structure was immediate occupancy, and the same performance level can be assigned to

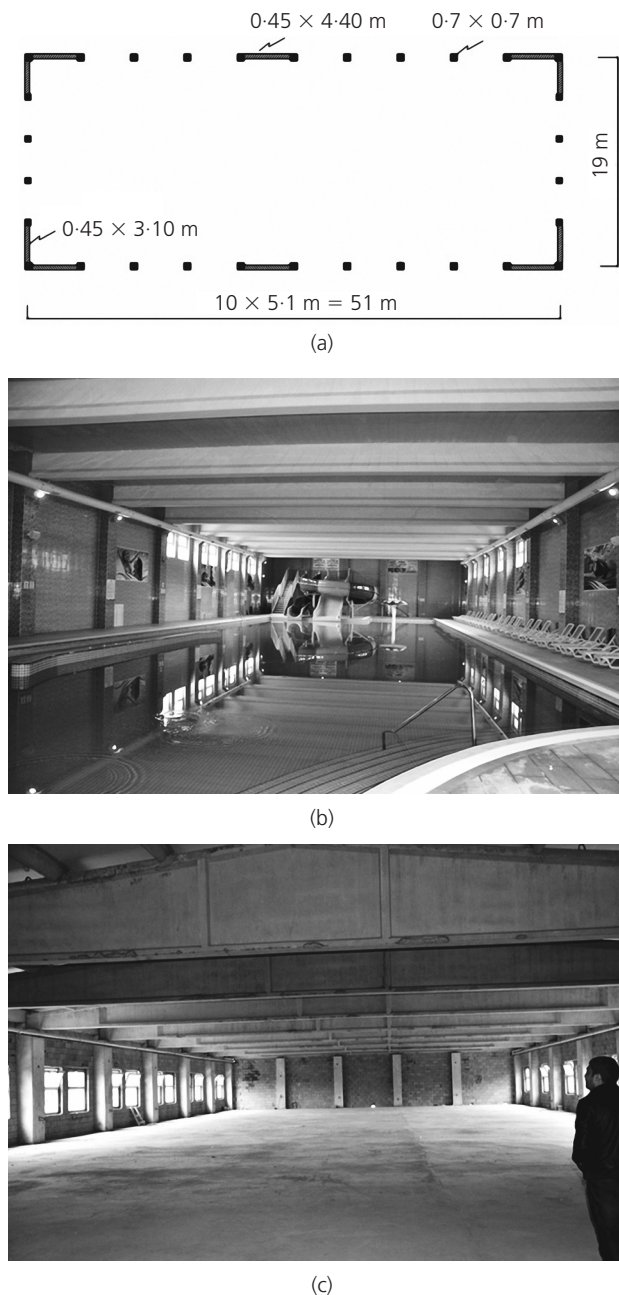
Figure 4. Precast concrete sport complex in the city centre of Van (courtesy of Serif Guner)

The one-bay precast concrete sport hall has two storeys with a plan dimension of 19 × 51 m, as shown in Figure 4(a). Each bay width in the longitudinal direction was measured as 5.1 m. The structure was constructed on a mat foundation and built with cast-in-situ shear walls in the first storey on both orthogonal directions (Figure 4(a)). The ratio of shear wall areas to the total plan area (shear wall index) in the longitudinal direction of the building was equal to 1.2% and this value was equal to 0.6% in the transverse direction. All of the beam to column connections in the structure consisted of two-pinned shear connections. Although reinforced concrete structures in the vicinity of the structure had significant damage, this sports hall was almost completely free of damage (Figures 4(b) and 4(c)). It is believed that such a successful earthquake performance may be attributed to the high cast-in-place shear wall index (greater than 0.5%) and to the existence of a rigid diaphragm at the first floor level.

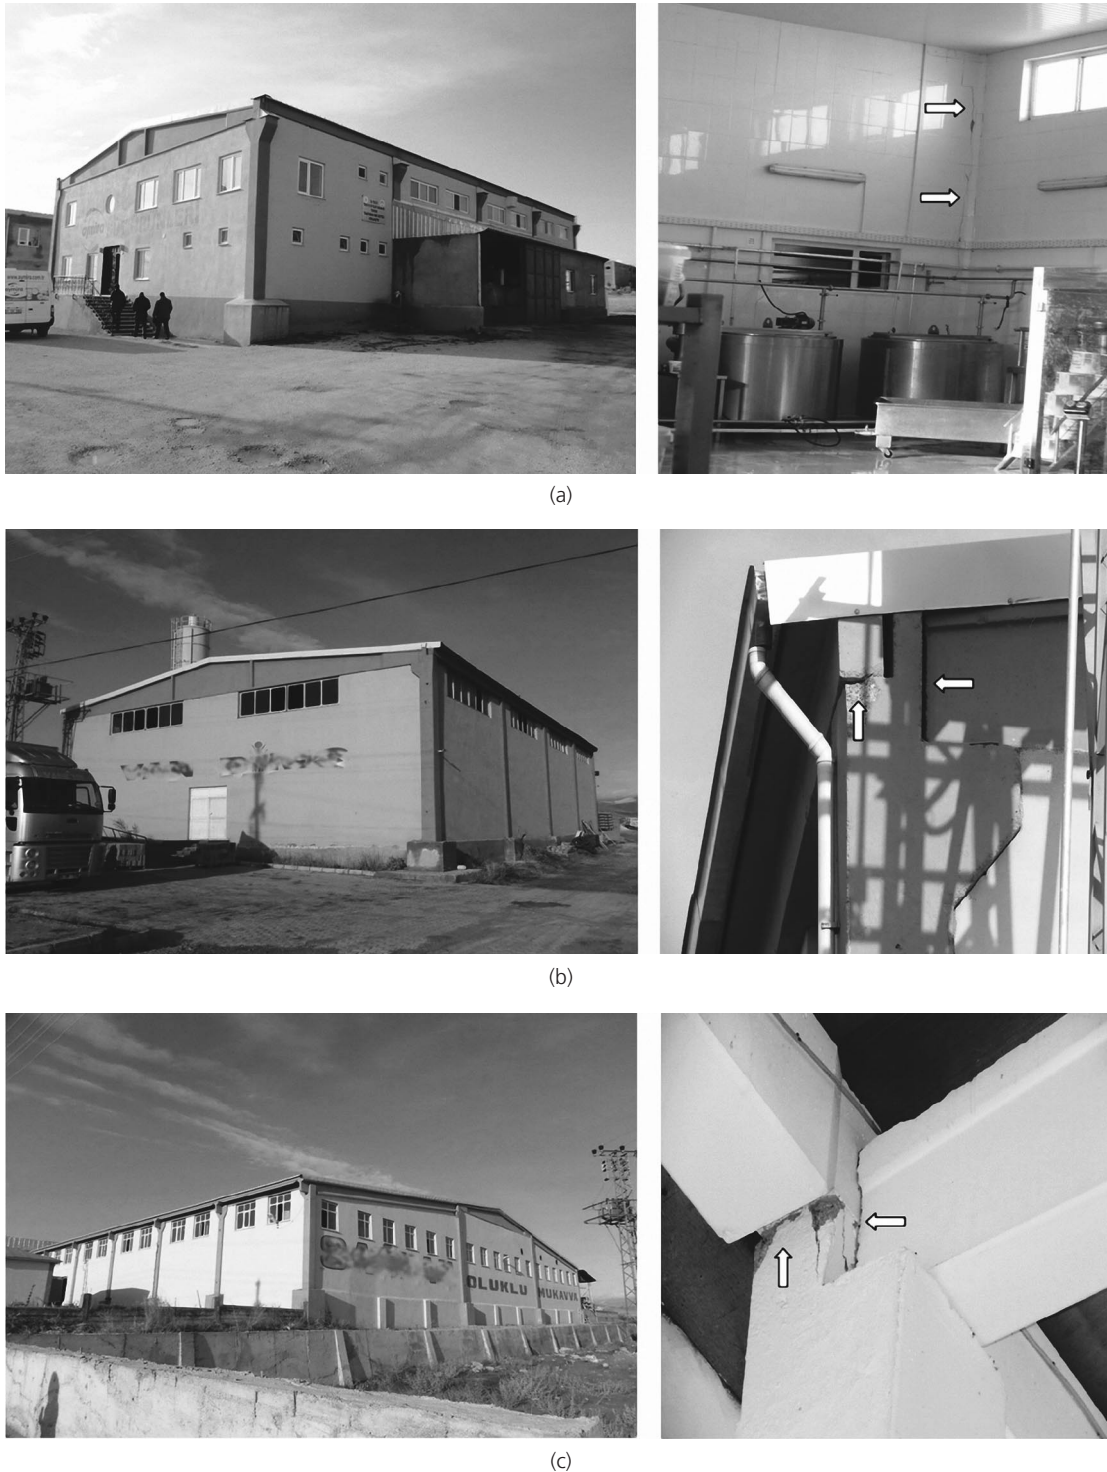
Figure 5. Examples of precast concrete facilities having light damage in the city industrial zone (CIZ) of Van city

The level of damage was low for the facilities that were in use during the earthquake. The existence of facade walls and roof cover plays an important role in reducing the damage level by maintaining extra lateral stiffness. Three of the precast structures graded as immediate occupancy are represented in Figure 5. Moreover, two facilities were in full production just a couple of days after the first earthquake. In some facilities, local settlement and heaving of the floor cover was observed on the opposite faces of the precast columns. In addition, owing to the deformation incompatibility, almost all of the precast concrete structures had cracks between structural and non-structural elements such as walls (Figure 5(a)). There was cracking and crushing at the corners of the structural elements in the joint regions because no

elastomeric bearings were used in the beam to column connections at the connection interface (Figure 5(c)).

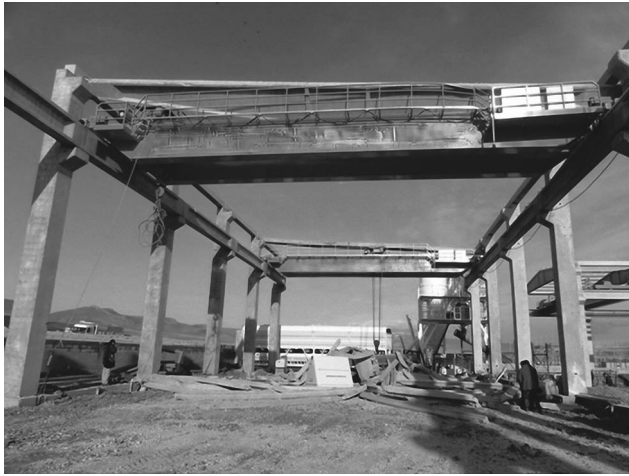
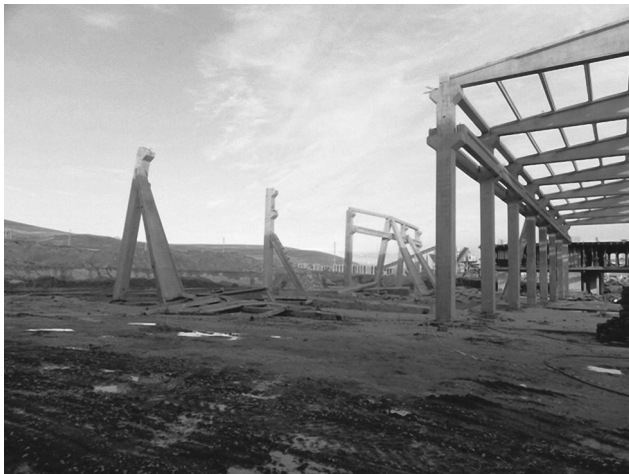
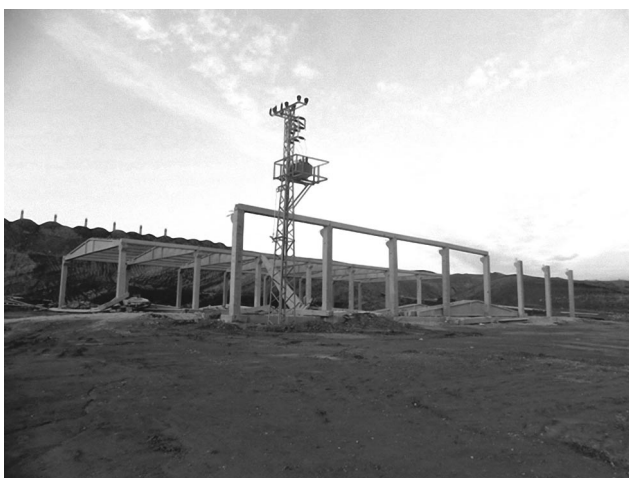
Figure 6. Heavily damaged precast concrete industrial facilities in the city industrial zone (CIZ)

storey drift, whereas the metallic roof cover results in a sort of diaphragm action. Three industrial buildings that were under construction and were heavily damaged after the 2011 Van earthquake are shown in Figure 6. The failure of these industrial buildings was mainly attributable to the falling of the roof beams. Although the falling of the roof beams might easily be attributed to the lack of grouting (as the building was under construction the producer claims that the earthquake happened just before grouting) at the pin supports at the connections, there were failures observed of connections where the grouting had recently been completed. It was also detected that the grouting mixture was not prepared appropriately (Figure 7(a)). Although some of

One of the partially collapsed precast concrete structures in the Van CIZ area is considered for performance evaluation (Figure 6(b), Figure 8(a)). The building was in the construction phase and no proper beam-to-column connection was supplied; it was clearly stated that structural integrity and planned framing action were not accomplished. Therefore, individual column performance was investigated by applying non-linear static analysis and response spectrum analysis. Cross-sectional dimensions of the column, the corresponding physical achievements of which after earthquake are shown in Figures 7(b)–7(d), are represented in

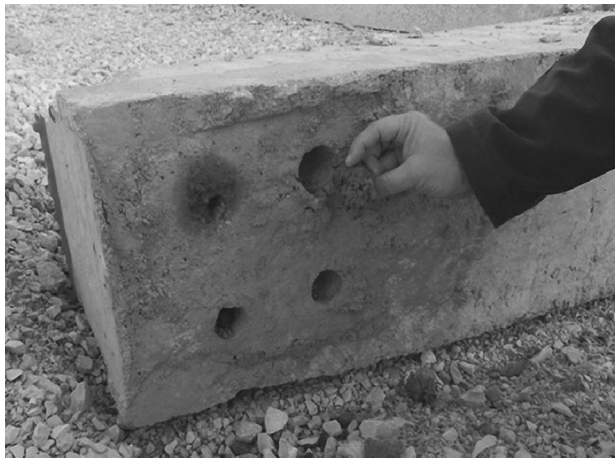
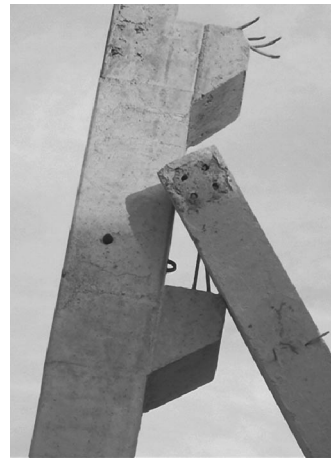
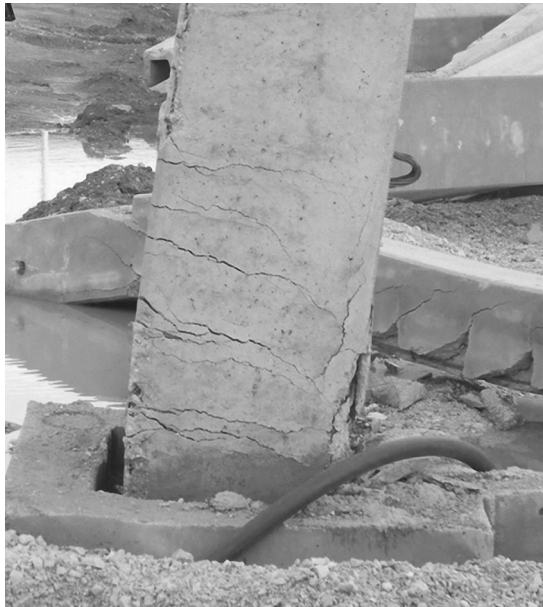
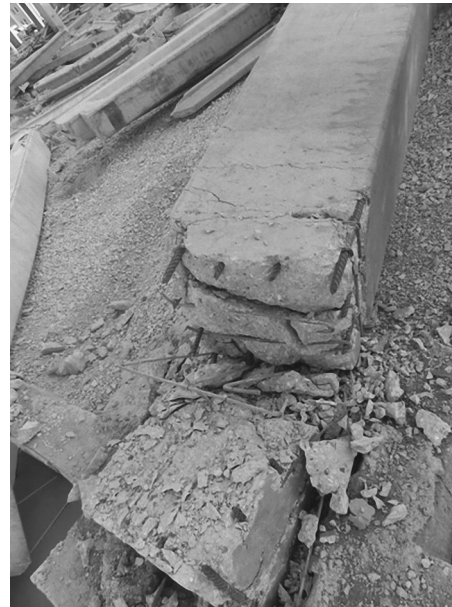
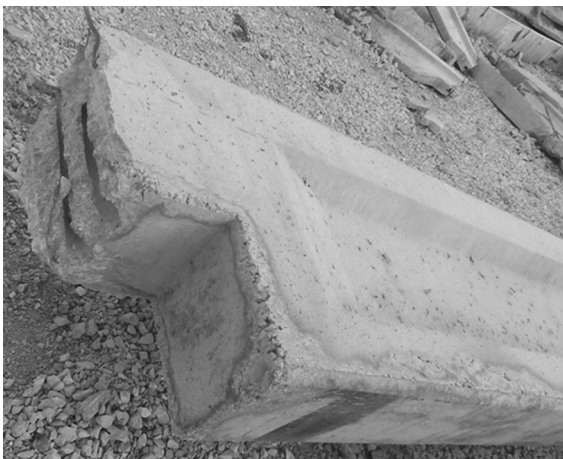
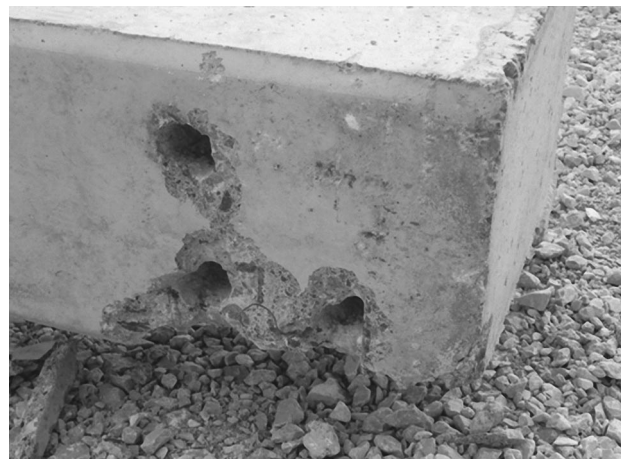
Figure 7. Close-up views of damaged members

the re-bars protruding from the corbels have threaded ends connecting the column and the roof beam, no nuts and washers were used during the assembly process (Figure 7(b)). In the spans where the roof beam to column connections worked well on one end and failed on the other, the columns not only underwent inertia forces but also the gravity forces and extra moment created by the falling of the roof beams, resulting in flexural hinging at the column bases (Figure 7(c)). This situation might have been caused by the possibility that some of the holes were grouted and some of them were not (while one end of a beam

could have easily demounted, the other end was still connected to the column tip causing extra force and moment on the column base and extra displacement demand). The longitudinal reinforcement in such columns experienced yielding, even strain hardening and rupture, resulting in total collapse of the columns (Figure 7(d)). Surprisingly, it was observed that the column longitudinal reinforcement ratios for the collapsed precast frames ranged between 0.60% and 0.75%, which is very low compared to design calculations. The plastic hinge length for the columns with such low reinforcement ratios was approximately 1 to 1.5 times the column cross-section. TPCA also conducted detailed investigations on the quality of reinforcing steel. For this purpose, samples were taken from the field and mechanical tests were performed in an accredited laboratory for the determination of reinforcement quality with respect to allowable limits proposed by the TEC (2007) and Eurocode 2 (BSI, 2004) provisions. Table 1 denotes the test results of the samples (supplied by TPCA). It is apparent from the results that the re-bar diameter, yield and rupture strength values are not satisfying the limits defined by the TEC (2007) and Eurocode 2 (BSI, 2004). Especially for the first and second samples the yield and rupture strengths are almost equivalent and the elongation at rupture values are below the limits leading to brittle behaviour. The bending angles at the ends of the cross-ties (not the peripheral hoops) were allowed to be 90° on one end and 135° on the other, provided that the consecutive two cross-ties did not have the same angle on the same sides according to the TEC (2007). A similar recommendation is also outlined in Eurocode 8 (BSI, 2005). This alternative use of cross-tie ends was not observed in the failed column cross-sections. Compressive crushing and tensile cracking took place at nearly all the beam column connections, no matter whether the frame was failed or not. It was apparent that no elastomeric pads were used in either failed or non-failed pre-cast concrete structures. In some collapsed frames, it was observed that the radial or confining reinforcement around re-bar holes for the beam to column connection was missing (Figure 7(e)). In some structures, the number of holes was inconsistent (Figure 7(f)). Such observations are good examples for the low construction quality and assembly practice in the local area. The similar deficiencies observed in 1998 Adana-Ceyhan earthquake and 1999 Kocaeli earthquake, caused the failure of the precast industrial frames in the October 2011 Van earthquake.

and roof covers experienced various damage levels. The authors believe that the responses of industrial structures are mostly influenced by the lateral drift levels. The reduced drift levels protect the connection from failure and hence attain structural integrity throughout the seismic excitation. In addition, field investigations also revealed that the need for elastomeric bearing pads in the connection region between beam end and corbel is crucial in preventing the formation of cracks and concrete corner crushes at this region. Furthermore, collapsed structures that were under construction during the earthquake indicated that grout injection and securing the re-bars passing through the holes placed at the ends of the beams should be applied in all connections immediately after placing the beams on top of erected columns for providing the complete framing action. Simple and free seating of the beam on the corbels, just relying on the re-bars passing through the holes without grouting and securing processes, should be avoided.

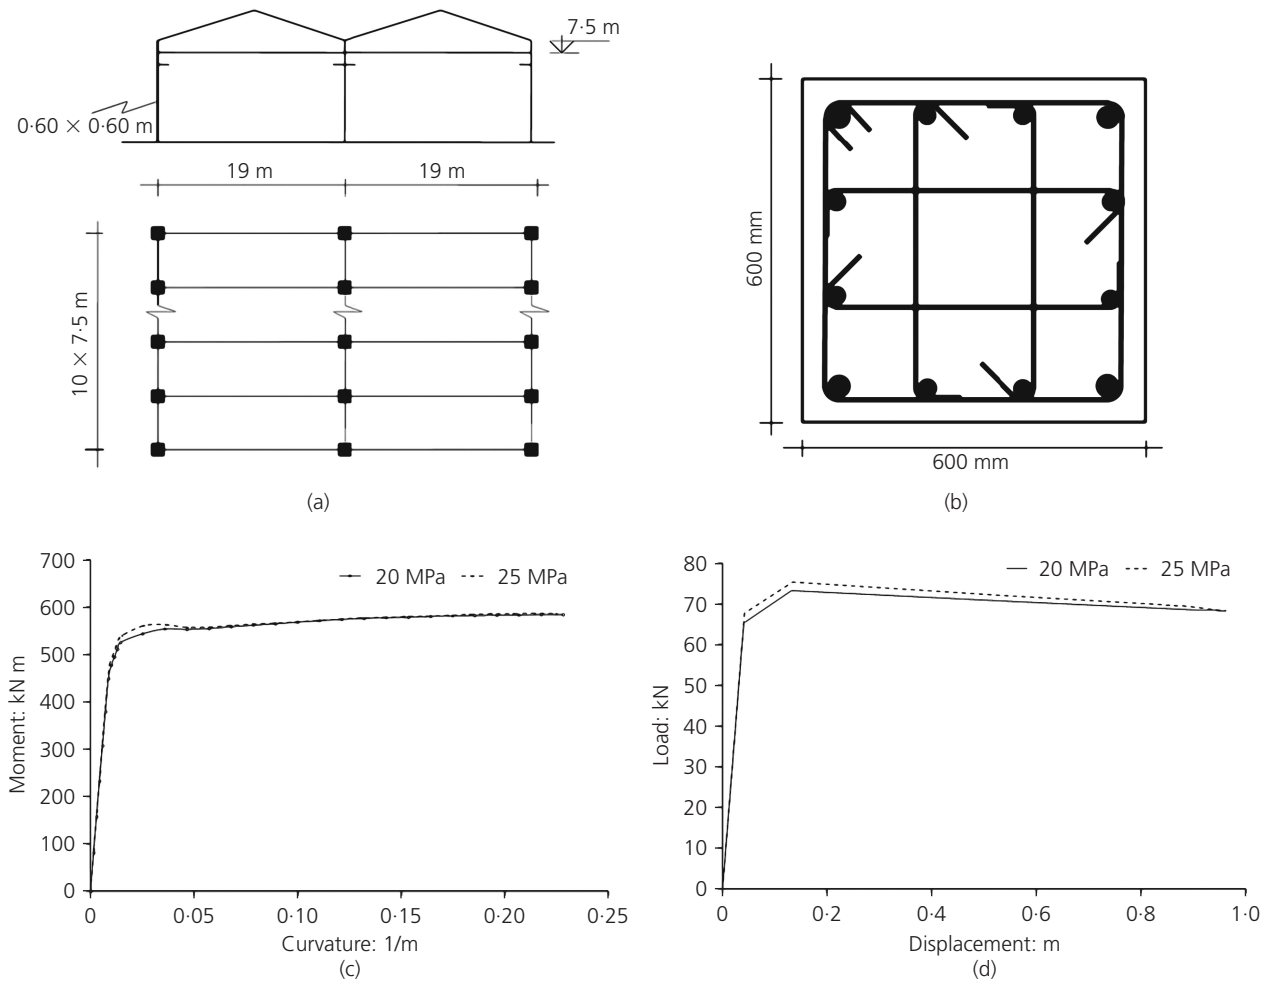
Figure 8. (a) Plan and elevation of partially collapsed structure;
 (b) cross-section of the column; (c) moment–curvature graph;
 (d) load–deformation graph of column

Figure 8(b). Although the planned column dimensions were 0.7×0.7 m in the original blueprints of the structure, the in situ column dimensions were detected as 0.6×0.6 m. It was also observed that the reinforcement ratio in the in situ column was

about 0.95%, instead of 1.35% as stated in the blueprints. In light of this information and the test results given in Table 1, the yield strength and rupture strength of the reinforcing steel were assumed as 690 MPa and 730 MPa respectively. Elongation at

rupture of the steel was considered as 10%. The longitudinal reinforcing steel ratio in the cross-section was assumed to be 0.95% and the transverse reinforcement having diameter of 8 mm and spacing of 100 mm was considered in the cross-sectional analysis (Figure 8(b)). As the concrete strength was not clear for the structure, two different concrete cylinder strength values, 20 and 25 MPa, were employed for the cross-sectional analysis considering the poor workmanship effect observed in the site. The moment–curvature relationship of a single column obtained by using the aforementioned structural parameters is presented in Figure 8(c). It is clear from the graph that variation of the concrete strength, 20 to 25 MPa, did not cause a significant difference in the moment–curvature relationship. The yield moments of the column for 20 and 25 MPa concrete strength were 477.6 and 496 kNm respectively.

As the structure was under construction during the earthquake, the only axial load carried by the columns was the weight of structural members such as roof beams, U-through and the crane beams. The weight of the roof beam was taken as 10 kN/m and it was considered that only half of the beam acted vertically on the column for load–deflection analysis. Extra weights coming from the other beams were ignored and it was assumed that they had totally fallen at the very beginning steps of shaking. The calculated axial load on the column was about 3% of its total axial load capacity. Hence, only a moment-dependent hinging mechanism was considered. The moment–curvature relationships were used for non-linear static analysis of the column. The plastic hinge length was taken as the width of column that is consistent with the site observations (Figures 7(c) and 7(d)). The lateral load that results in yielding of the column for 20 and 25 MPa concrete strength was computed as 65.22 and 67.73 kN respectively, as given in Figure 8(d). Moreover, the lateral load capacity of the column was 73.26 and 75.37 kN respectively. Response spectrum analysis was also performed for a single column by using the earthquake data measured at Muradiye station (Figure 2) and the consequent moment at the base of the column and shear load were computed as 463.3 kNm and 61.8 kN, respectively. It was believed that one end of the roof beam had fallen easily where it was seated on the column corbel at the middle axis, whereas the other end had not demounted. Therefore, it was considered that the falling beam at one side had also pulled the tip of the column at the other side until the total failure of the connection. It should

be noted that such a pulling effect was not accounted for during the design of this type of building. Obviously, the columns forced to almost their capacity with earthquake excitement collapsed with this diagonal pulling action. This also explains the survival of the columns that had not been subjected to the pulling effect of falling beams.
