EARTHQUAKE EXPERIENCE OF TURKISH PRECAST INDUSTRY

Abstract. *The high seismic activity of the three fault zones in Turkey developed damaging earthquakes in the last five decades that affected the precast-concrete building structures in the region. Among others, the 1998 Adana, 1999 Kocaeli, 2003 Bingol and 2011 Van earthquakes are considerably important regarding the seismic performance of the precast structures. Earthquake performance of frame structures in the form of industrial-halls, shopping malls, multi-storey residential buildings and gymnasiums along with the wall structures mainly in the form of residential housing, under these seismic actions, revealed valuable information on the effectiveness of the prevailing technology and the design practice. The quality control system, inherently developed within the member companies of the Turkish Precast Concrete Association, TPCA, resulted better performance of the precast structures. The structural system of the multi-storey residential buildings in Bingol, Kocaeli and Van, regardless of the structural system, were in the state of immediate occupancy, while the cast-in-place buildings in the vicinity experienced damage ranging f

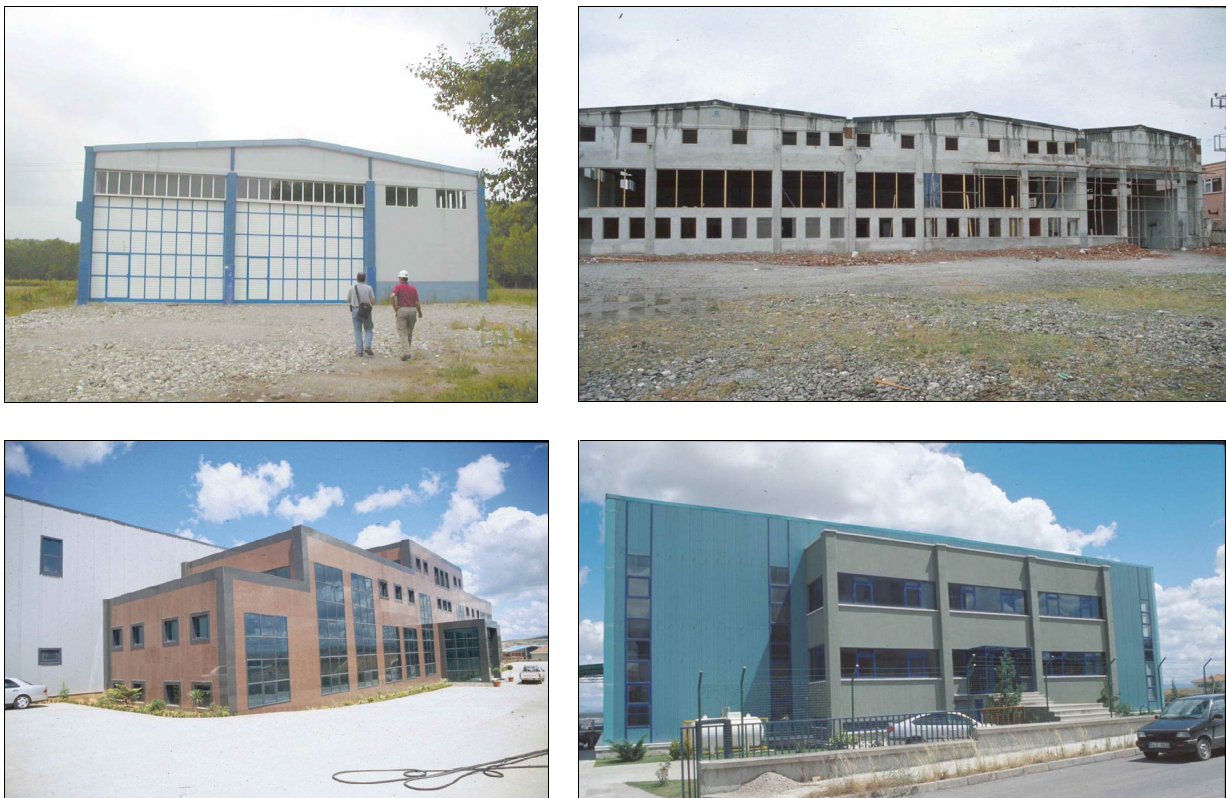
Figure 3 – Typical Single- and Multi-Storey Warehouses after Kocaeli Earthquake [5]

One year after Adana earthquake, Posada and Wood [5] reported similar results for the industrial buildings. Authors investigated the industrial buildings in Sakarya, Kocaeli, and Gebze. It is reported that the damage level of the industrial buildings are mainly influenced by the drift demand and the drift capacity of the buildings. The damage of precast structures in Sakarya was more pronounced due to the drift demand invoked by the soft soil conditions, as compared to the no damage in Gebze where the soil is basically stiff clay to rock. It is also reported that the buildings with larger column sizes, in other words the buildings conforming the Turkish Earthquake Code (TEC) performed well [5] (Fig.3). The site investigations and elaborations on the structural design calculations revealed that most of the damaged buildings were not conforming to the drift limits of TEC. Besides, the design was made only in the frame direction, and the earthquake loading is not made in the transverse direction. The damage of precast concrete industrial buildings conforming to the TEC drift limits on both orthogonal directions, even in the vicinity of the epicenter, were in the range of immediate occupancy to life safety [7].

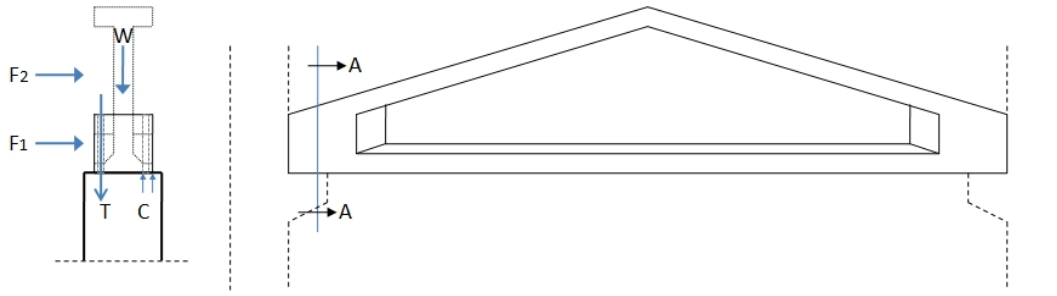
Figure 4 – Forces on the Roof Beams and the Resisting Mechanism

In some of the single-storey industrial buildings in Adana earthquake, the damage was confined to the out-of-plane toppling or leaning of the triangular roof beams. TPCA Technical Committee developed a design methodology and enforced the use of double bars to fix the triangular roof beams to the corbel of the columns (Fig.4). The forces F_i resulting from the earthquake excitation is resisted by the moment around a beam corner due to gravity and due to the force couple created by the double bars as shown in Fig.4. [8].

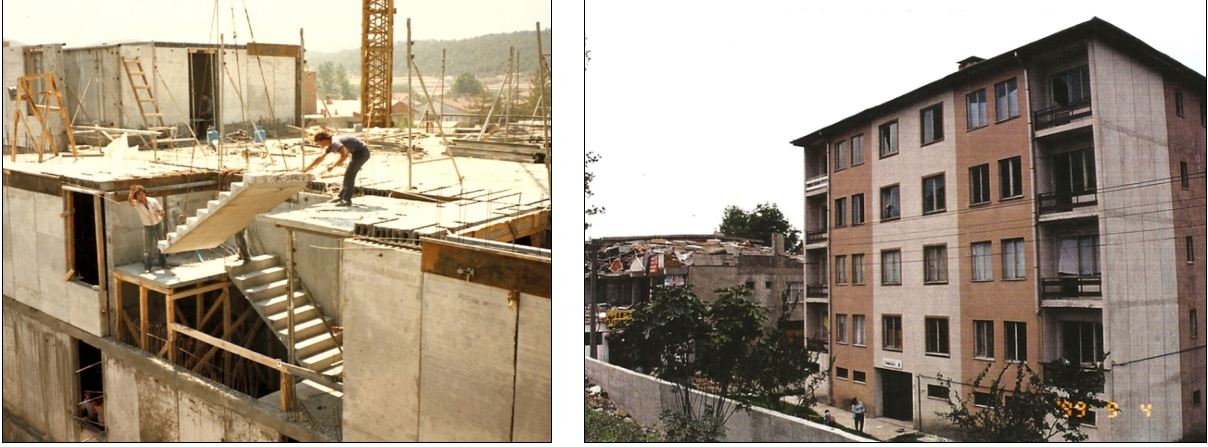
Figure 6 – Precast Multi-Storey Wall System Building during Construction and After 1999 Kocaeli EQ. [10]

In 1999, a devastating earthquake hit the city of Kocaeli leaving thousands of casualties and a considerable economic loss both due to the damage in infrastructure and due to the industrial production losses (Table 1). The spread of damage was more pronounced in the sediment basins such as Adapazarı, and in the regions close to the East bound of the Kocaeli Gulf such as Golcuk and Kavaklı. The displacement demand due to the soft sub-layers caused many buildings to collapse, left many beyond the life safety performance limit. The precast wall type of 5 storey residential construction at Golcuk, which was constructed in 1991 experienced no damage (immediate occupancy performance level) while all the surrounding buildings were collapsed. The walls and the slabs of the building complex with 2

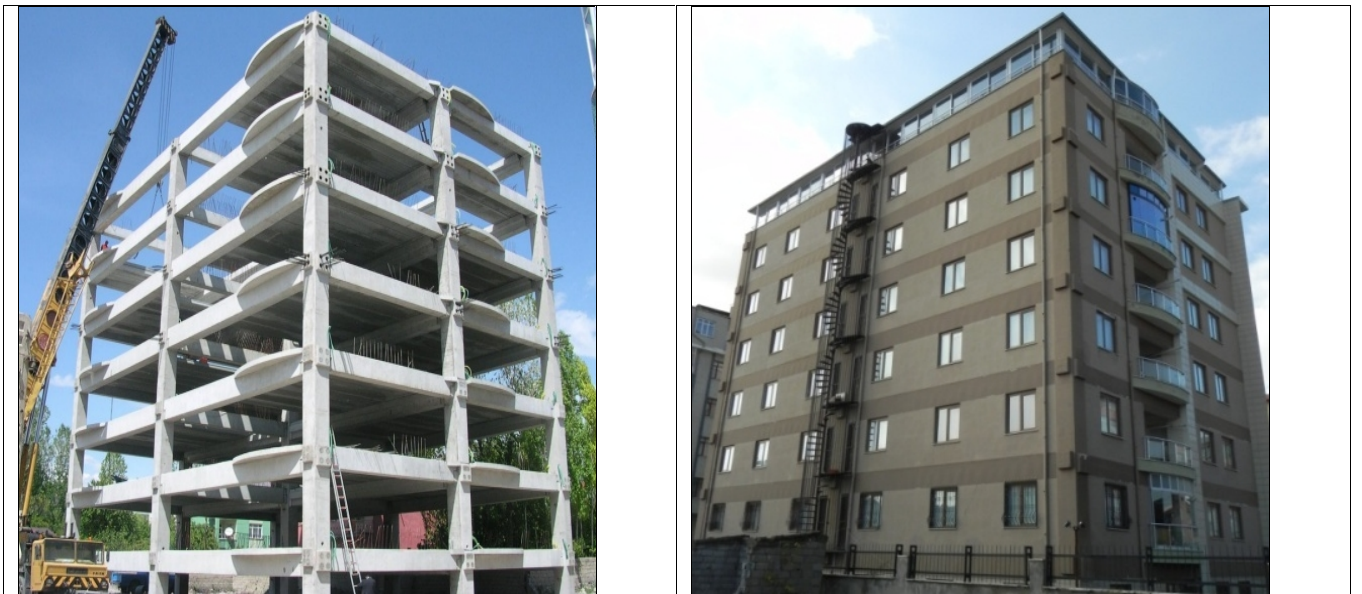
Figure 8 – Frame Building with Post Tensioned Connections, and the Performance after 2011 Van EQ. [11]

Post-earthquake damage investigation on that specific building revealed no structural damage on neither pre-cast, pre-tensioned members, nor the post-tensioned connections, and post-tensioning ducts. The column to foundation connections were carefully investigated and no flexural or shear cracking was observed. The frame performance during the Van Earthquake of October 2011 was immediate occupancy. However, some the dry partition walls experienced minimal damage.

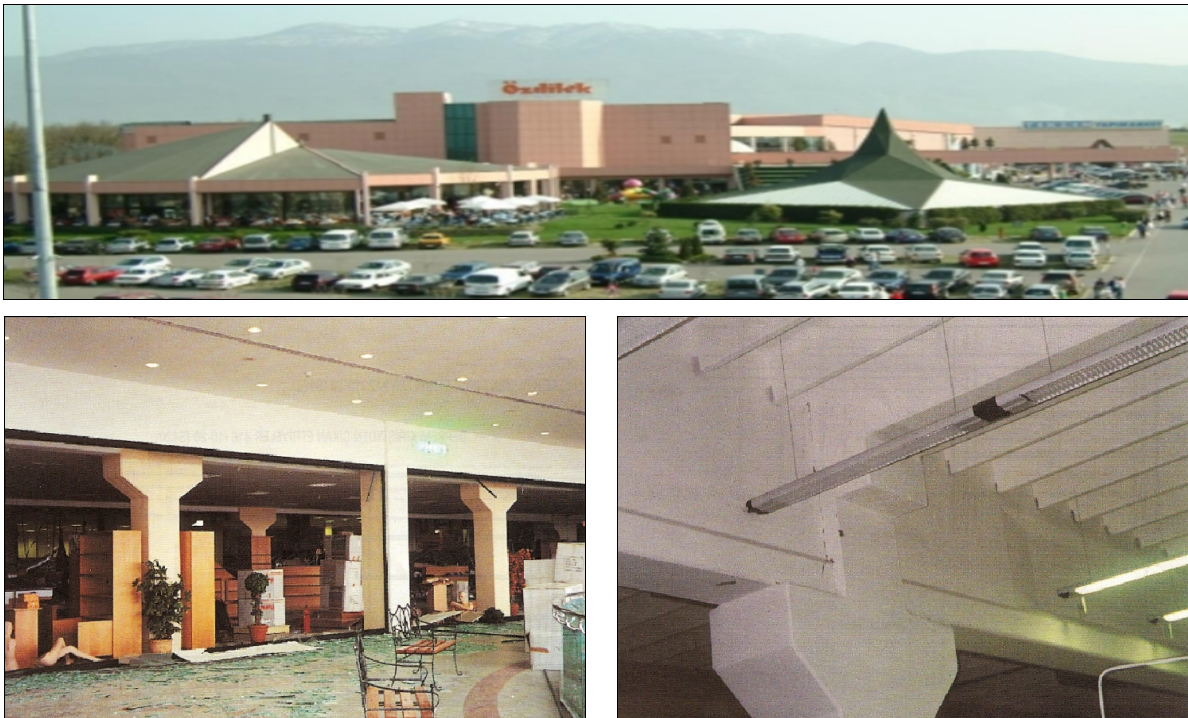
Figure 9 – Performance of a Shopping Mall after 1999 Kocaeli Earthquake [12]

frames were three storey height. The frame connections were cast-in-place. The structural system was in the immediate occupancy performance level. However, the false ceilings and the material racks toppled and service of the mall suspended for a while.
