## **Rehabilitation of Beams with Externally Bonded Reinforcement**

**Ş. Özden, T. Özturan**

**Fourth International Conference  
on  
Concrete Technology  
in  
Developing Countries**

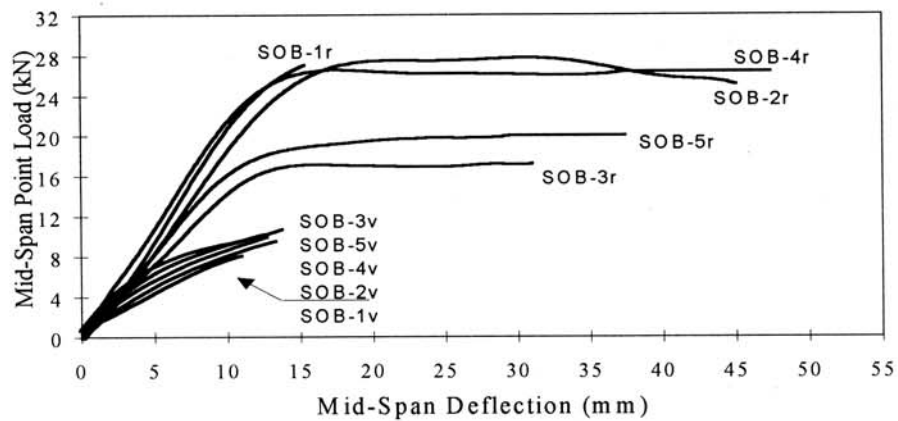
**Figure 1** - Experimental Load-Deflection Behaviour at Mid-Span

Load-Midspan deflection and Moment-Curvature diagrams (Figures 1 and 2) clearly show that the externally bonded reinforcement causes a noticeable improvement in the mechanical behaviour of repaired beams over the virgin ones (Table 5). In those diagrams, although the concrete strength was ranging from 26 to 41 MPa in repaired specimens, no attempt was made to normalize the curves. Comparing the virgin and repaired specimens it is seen that the initial stiffness of the repaired beams are much higher than that of the virgin ones. Moreover, this rehabilitation technique carries the yield load to a higher value.

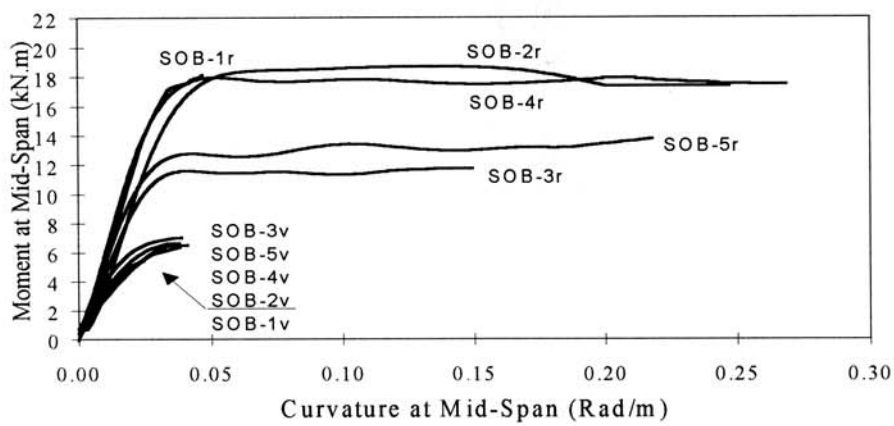
**Figure 2** - Experimental Moment-Curvature Behaviour at Mid-Span

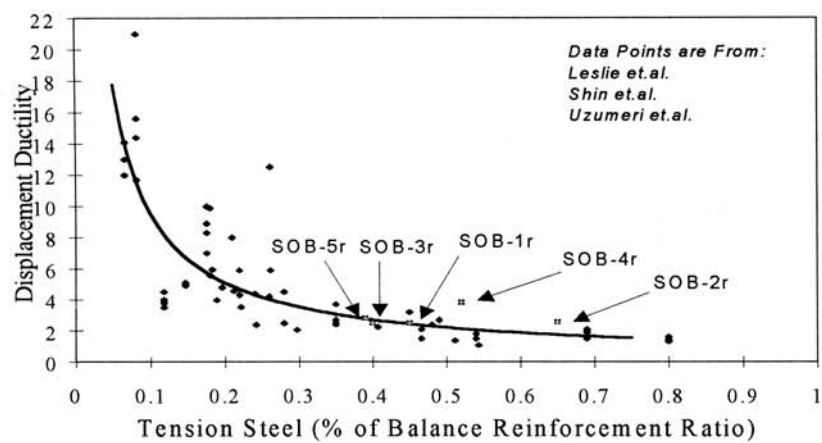
**Figure 3** - Effect of Amount of Tension Steel on the Displacement Ductility [4]

In the published research[1,2,3] in this field, it is agreed that the application of externally bonded reinforcement rapidly decreases the ductility of the structural elements; and most of the times this conclusion is given as if it is not expected. If we analyze Figure 3 [4] which includes the test results of many different researchers, it is seen that the ductility of a section is closely related to the  $\rho/\rho_b$  value and the specimens of the current research is in the same trend of the previously reported non-rehabilitated specimens. This indicates that the decrease in ductility is from the virtue of an increase in  $\rho/\rho_b$  and not only of the existence of externally bonded plate.
