EARTHQUAKE EXPERIENCE OF TURKISH PRECAST INDUSTRY

Abstract. *The high seismic activity of the three fault zones in Turkey developed damaging earthquakes in the last five decades that affected the precast-concrete building structures in the region. Among others, the 1998 Adana, 1999 Kocaeli, 2003 Bingol and 2011 Van earthquakes are considerably important regarding the seismic performance of the precast structures. Earthquake performance of frame structures in the form of industrial-halls, shopping malls, multi-storey residential buildings and gymnasiums along with the wall structures mainly in the form of residential housing, under these seismic actions, revealed valuable information on the effectiveness of the prevailing technology and the design practice. The quality control system, inherently developed within the member companies of the Turkish Precast Concrete Association, TPCA, resulted better performance of the precast structures. The structural system of the multi-storey residential buildings in Bingol, Kocaeli and Van, regardless of the structural system, were in the state of immediate occupancy, while the cast-in-place buildings in the vicinity experienced damage ranging f

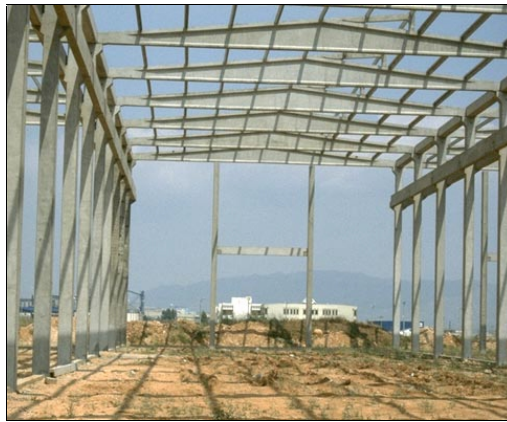
Figure 2 – Industrial Building under Construction in Adana in 1998 [6]

Adana (on EAF), Kocaeli and Sakarya (on NAF) are the industrial heartlands of Turkey and hit by two devastating earthquakes in the year 1998 and 1999 respectively. The precast construction in Adana was mainly in the form of single storey industrial buildings, while multi-storey industrial buildings also exist in the Kocaeli region. The structural system of single storey industrial buildings consists of cantilever columns, fixed at the base and pin connected to the roof beams at the top. It is reported that the workmanship and the material quality of the precast concrete elements in Adana were significantly over those of the cast in place residential buildings (Fig.2). It is also reported that the Schmidt hammer measurements of the concrete elements yielded a mean value for the compressive strength of $f_c = 60 \text{ N/mm}^2$ while the yield strength of the reinforcement steel is assumed to be $f_y = 420 \text{ N/mm}^2$ [6]. The local damage of such buildings were confined to the connections where roof beams were pin con-

nected to the columns. The structures conforming to the Turkish Earthquake Code experienced minimal damage confined to the partition walls and some connections, while the ones not conforming to the code experienced local failures. The column dimensions played an important role on the damage distribution in such buildings.

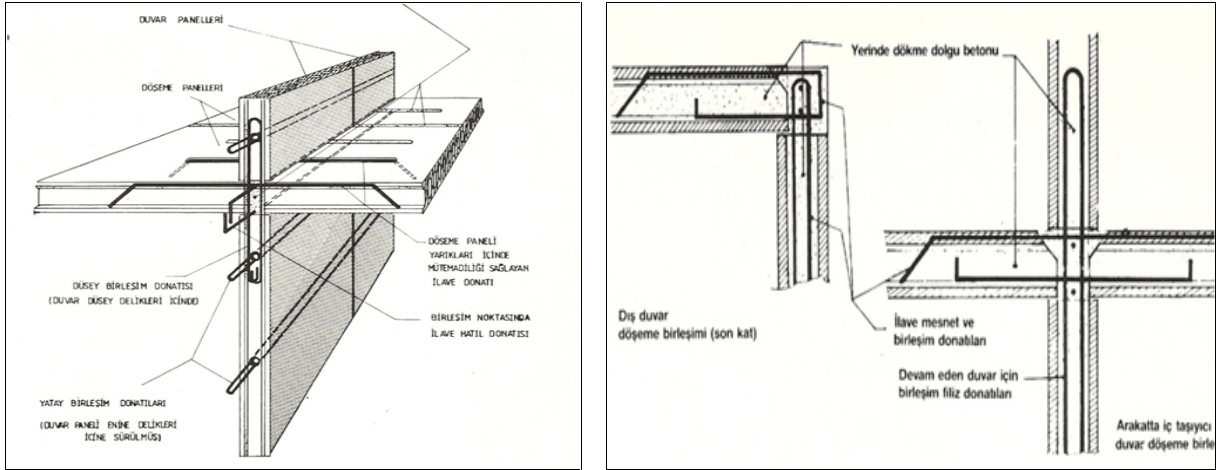
blocks were of hollow core slabs. The wall to slab and wall to wall connections were cast-in-place with special reinforcement detail (Fig.7).

Figure 7 – Slab-to-wall and Wall-to-Wall Connections in Multi-Storey Wall System Building. [10]
