CFRP OVERLAYS IN STRENGTHENING OF FRAMES WITH COLUMN REBAR LAP SPLICE PROBLEM

Abstract. This study is part of a research program within the framework of NATO Project 977231 “Seismic Assessment and Rehabilitation of Existing Buildings” led by METU. A new seismic retrofitting method by using CFRP cross overlays is experimentally investigated. Five specimens were tested to highlight the effect of brick infill and epoxy bonded CFRP overlays on the strength and behavior of poorly detailed reinforced concrete frames. The main deficiencies of the one-third scale one-bay, two-story frames tested were low concrete strength, insufficient column lap splice length, poor confinement, and inadequate anchorage length of beam bottom reinforcement. In all specimens beams were stronger than columns and no joint shear reinforcement was used.

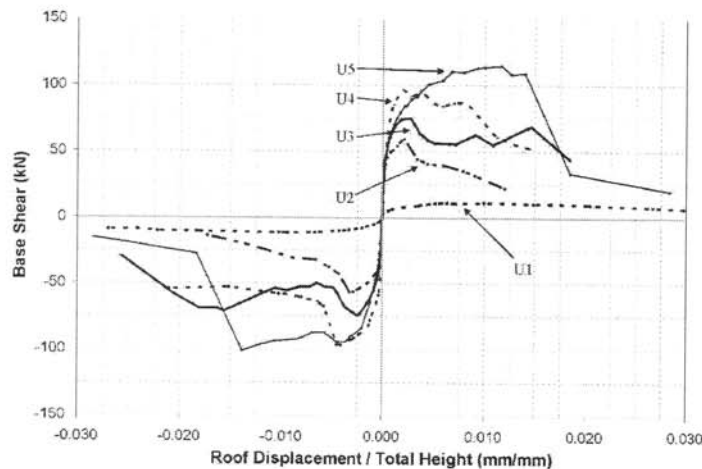
Response envelope curves are developed by connecting the peak values of each cycle for all specimens (Figure 5). Load bearing capacities of all strengthened frames tested are significantly higher than that of the bare frame (Sp-U1) and the unstrengthened infilled specimen (Sp-U2). Although there was a significant strength enhancement in Sp-U5 (1.94 times that of Sp-U2), the enhancement in displacement capacity was more pronounced (5.3 times that of Sp-U2).

Figure 5. Response envelope of specimens

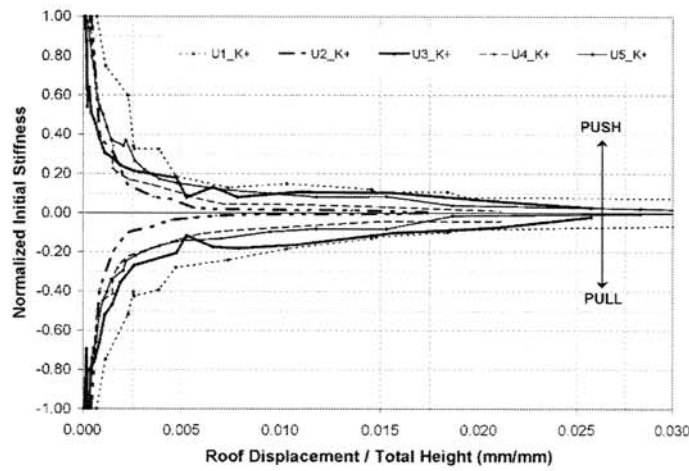
Moreover, the tangent slopes of the load-displacement curves which are called "tangent stiffness" were calculated for each specimen. These representative slopes referred to each forward and backward cycle are all calculated from the experimental load-displacement curves. The degradation of normalized tangent slopes for the forward and backward cycles with corresponding specific roof story drift ratio are given in Figure 6. The drift ratio exceeds 2 percent for bare frames and 0.5 percent for infilled frames, and the amount of stiffness degradation was more than 90 percent for almost all specimens beyond a drift level of 1 percent.

Figure 6. Variation of initial stiffness for each forward and backward cycle
